AFFDL-TM-73-136-FEE

**TEST EVALUATION OF THE
C-5A EMERGENCY OXYGEN
GENERATOR AS A POSSIBLE
CAUSATIVE AGENT OF FIRES**

OCTOBER 1973

A fire occurred in an aircraft equipment storage depot at Travis AFB, California on 17 August 1973. Post-fire investigations resulted in the tentative conclusion that the fire was caused either by arson or malfunction of C-5A emergency oxygen generators stored in the depot at the time.

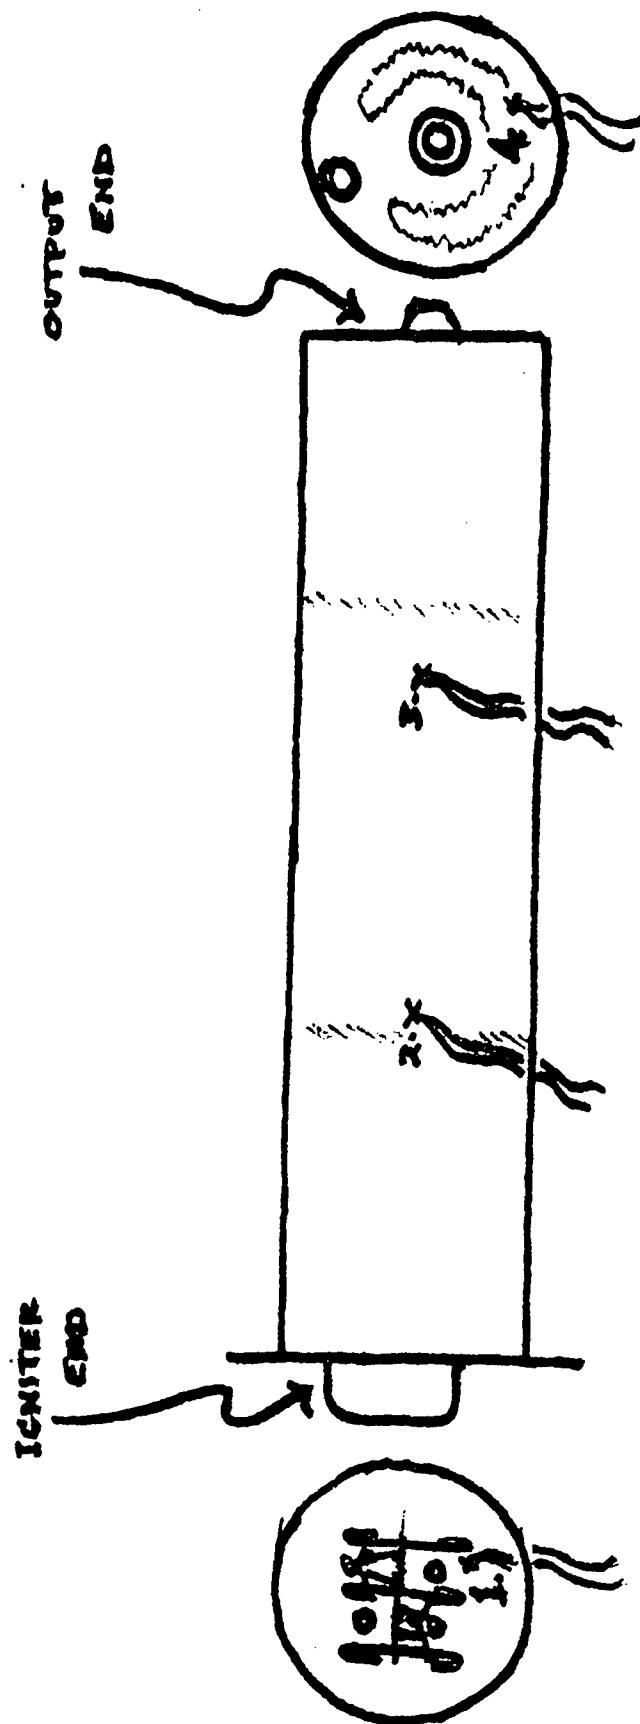
FIGURE 9 - Positions of Thermocouples on Generator

Test #5 - Several iron-constantan thermocouples were attached to the replacement cartridge of a generator. Figure 9 illustrates schematically the locations of the thermocouples as attached. The unit was activated and the following time-temperature data recorded:

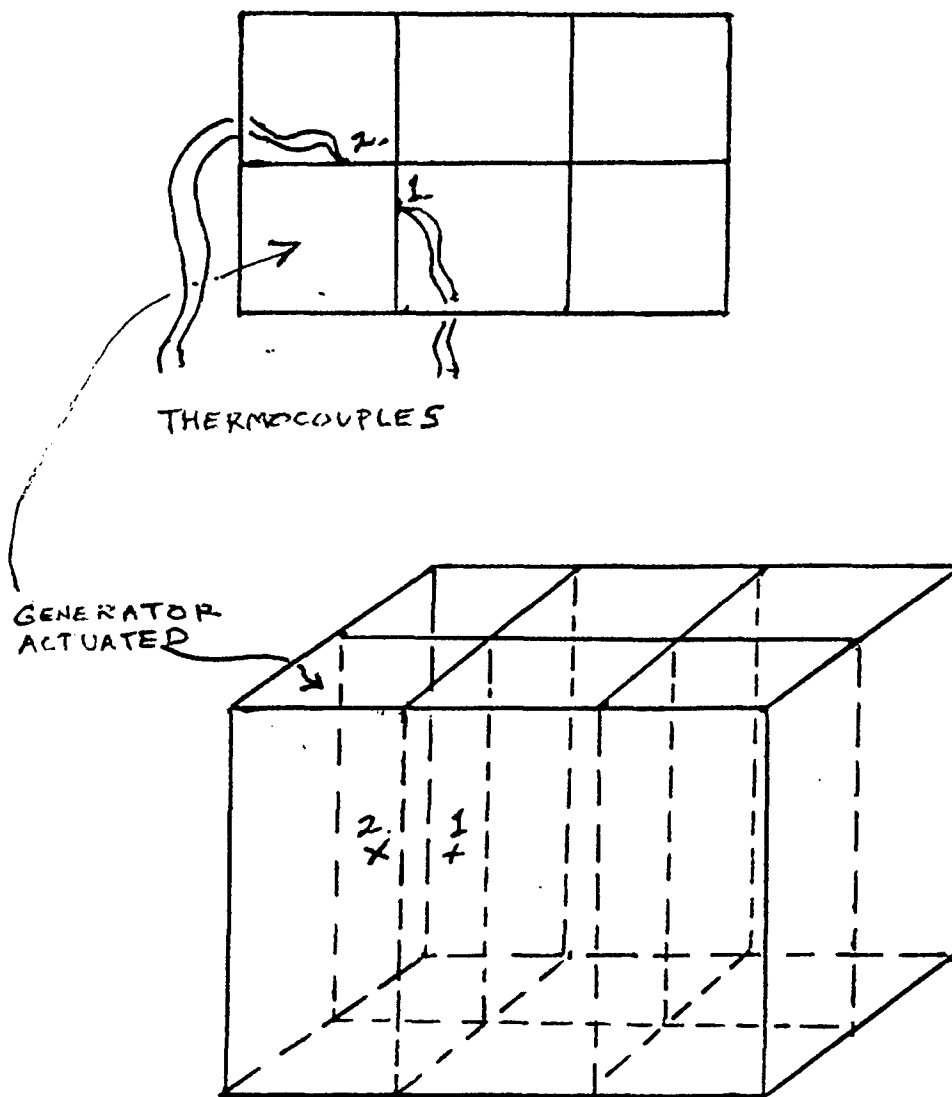
FIGURE 10 - Carton Thermocoupled for Test

Test #8 - A carton containing six packaged generators was selected. One of the packaged generators was outfitted with two thermocouples (on the outside of the package) as depicted in Figure 10. The generator was then re-inserted in the carton with a primer lanyard drawn through the carton and activated. Temperature data which was recorded through the duration of generator operation is listed as follows:

Since only one primer was activated, the other primer probably actuated within seconds afterwards. The exact time, however, was not determined. The results of this test were that the tygon hose from the generator to the mask melted at several points with overall scorching noticeable. The breathing bag off the mask also melted and the outer polycarbonate housing softened and buckled around the vent ribs. There were no other signs of damage to the generator and no fire occurred at any point within the carton.
